# Development and Application of BEOL Polymer Residue Removal Technology

## Abstract

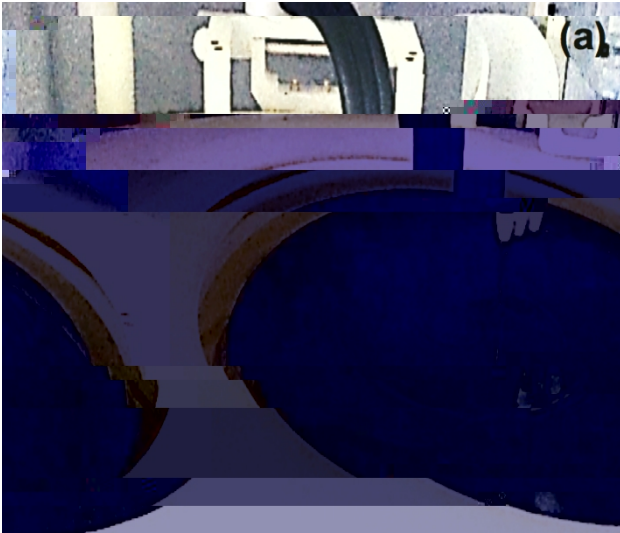
Fig. 6. (a) Captured image of ST250 layer thickness at a rotation rates of 400 rpm. (b) Water layer thickness profiles at the rotation rates of 200, 500 and 1400 rpm respectively [4].

Hypothesis 1:  
Hitoshi et al. found that in single-wafer wet cleaner, the local thickness of water layer is related to various parameters, such as wafer rotation speed and radical distance from wafer center [4]. As shown in Fig. 6(b), at the rotation rates of 200, 500 and 1400 rpm, the water layer thickness does not present steady curves as the radical distance changes. At the radial distance from wafer center of around 10mm, both liquid layer thickness and the radical velocity are much smaller than other zones (radical velocity profile is not shown). We suspected that the combination of thinner liquid layer thickness and slower radical velocity will result in poor chemical wetting at this local area, which consequently results in ball-type defect deposition. This phenomenon is more pronounced to high-viscosity chemical, such as ST250. The captured image in Fig. 6(a) also confirms this prediction. As shown in Table 1, viscosity of ICS8000 is much lower than ST250’s, which is the reason why ICS8000 does not suffer the ball-type defects (Fig. 5).
